MUNITIONS STORAGE SITE
NEAR LIU-CHOU, CHINA

CIA/PIR 63037

DATE FEB 1966

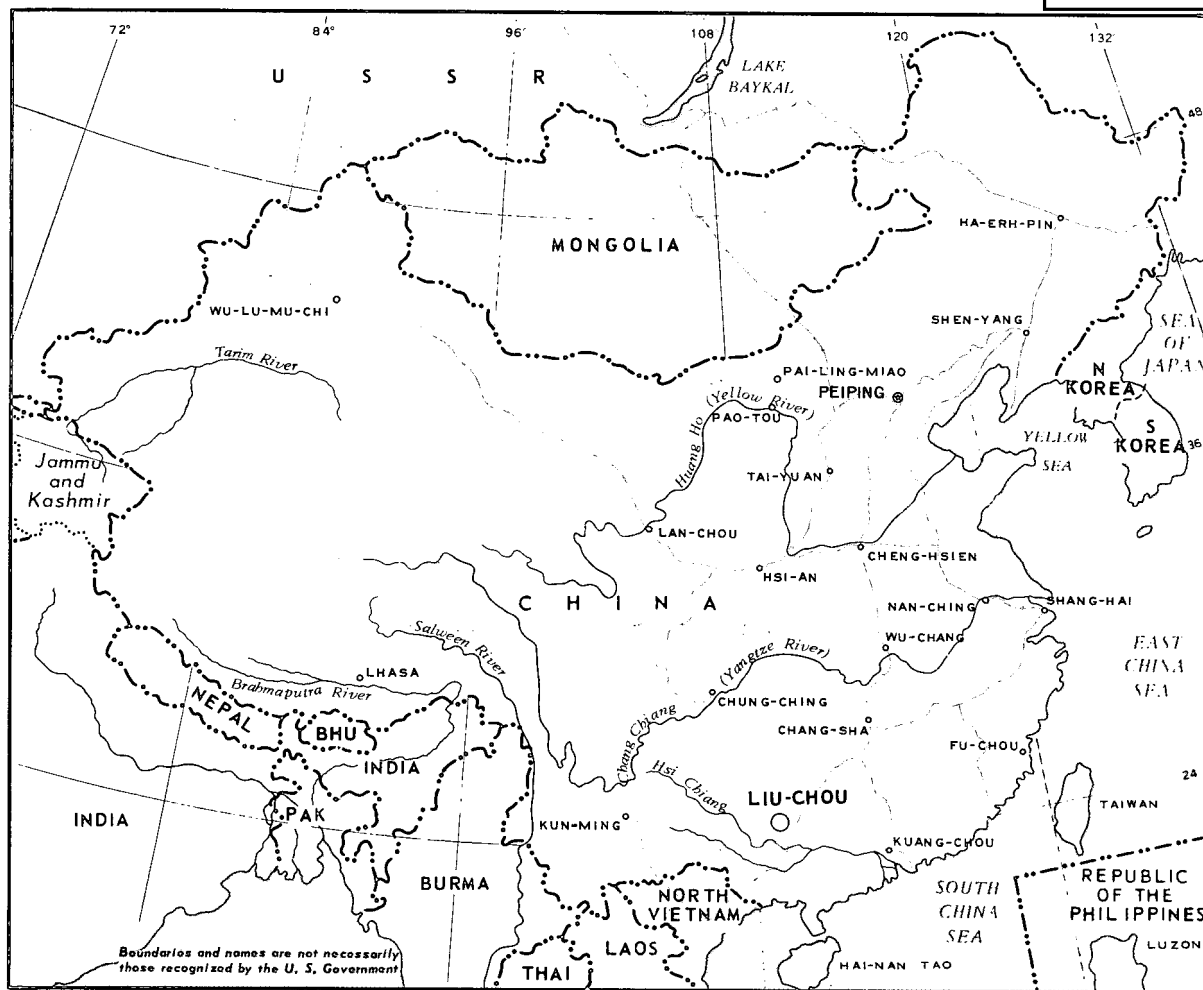
Figure 1.

A previously identified munitions storage site is located 14.5 nautical miles WNW of Liu-chou, China (Figure 1). The site is road served and is situated in a valley partially surrounded by rugged hills (Figure 2).

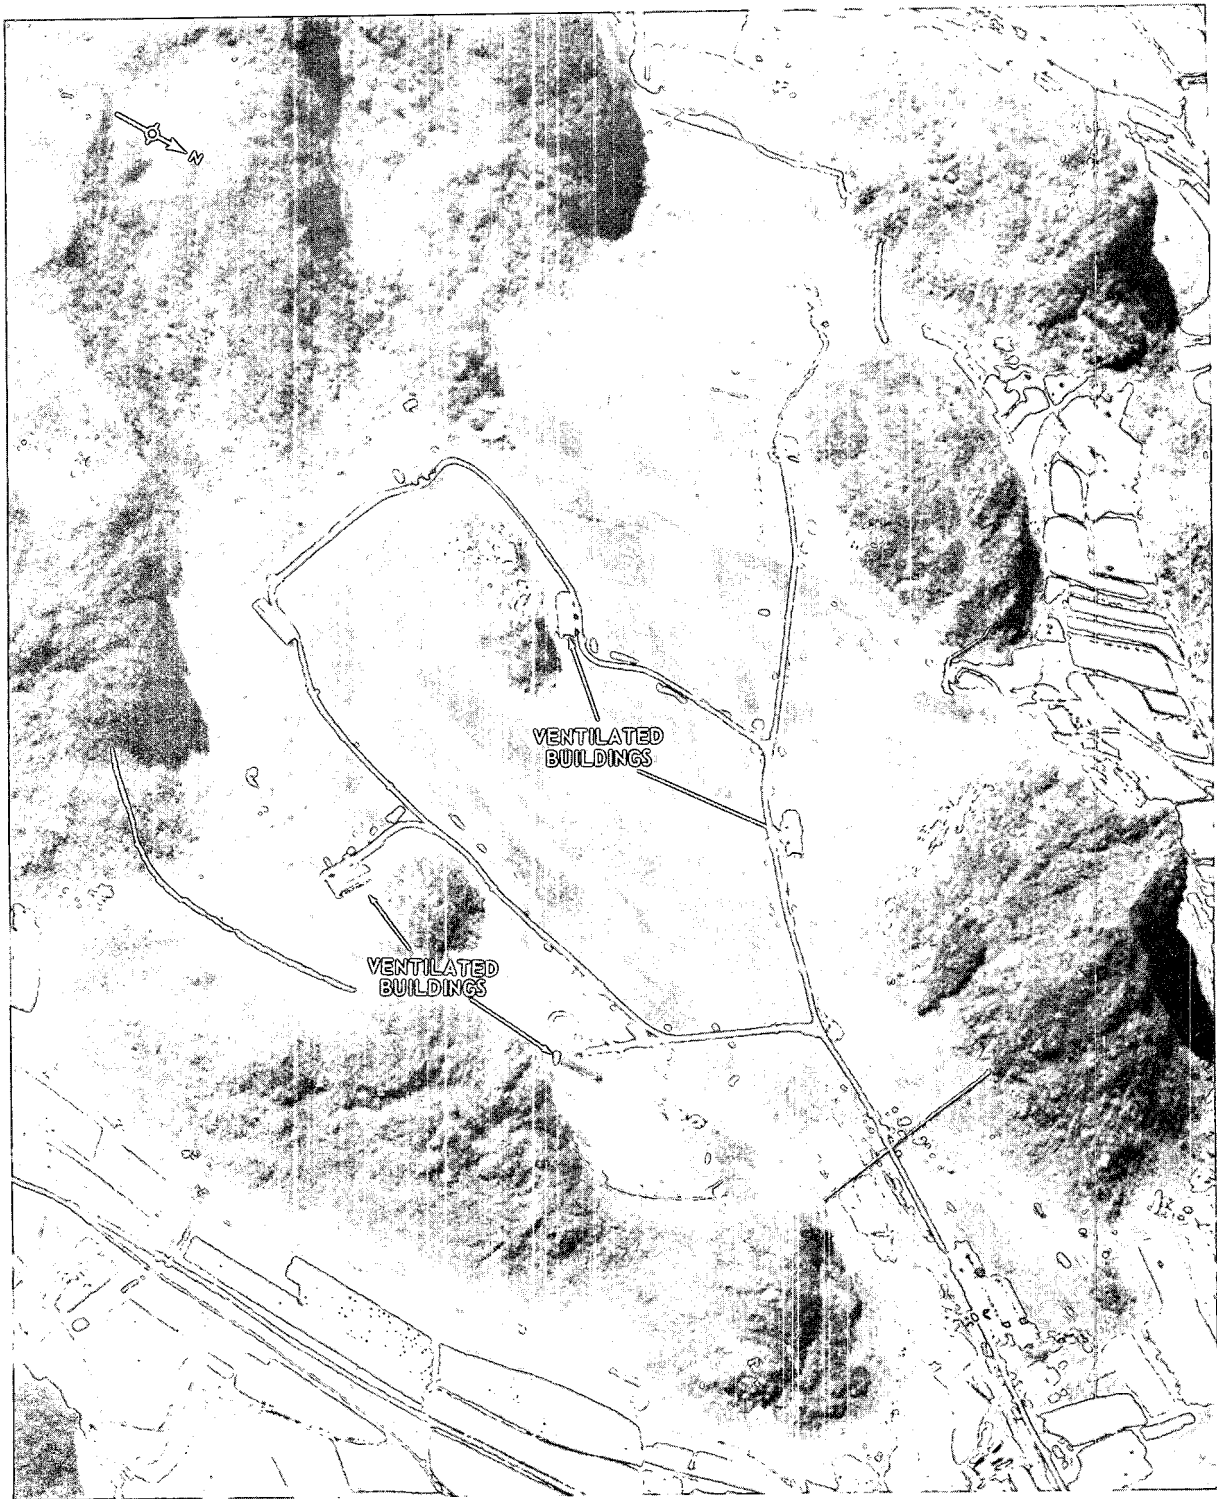
Figure 2. Munitions storage site near Liu-chou, China. Date of photography:

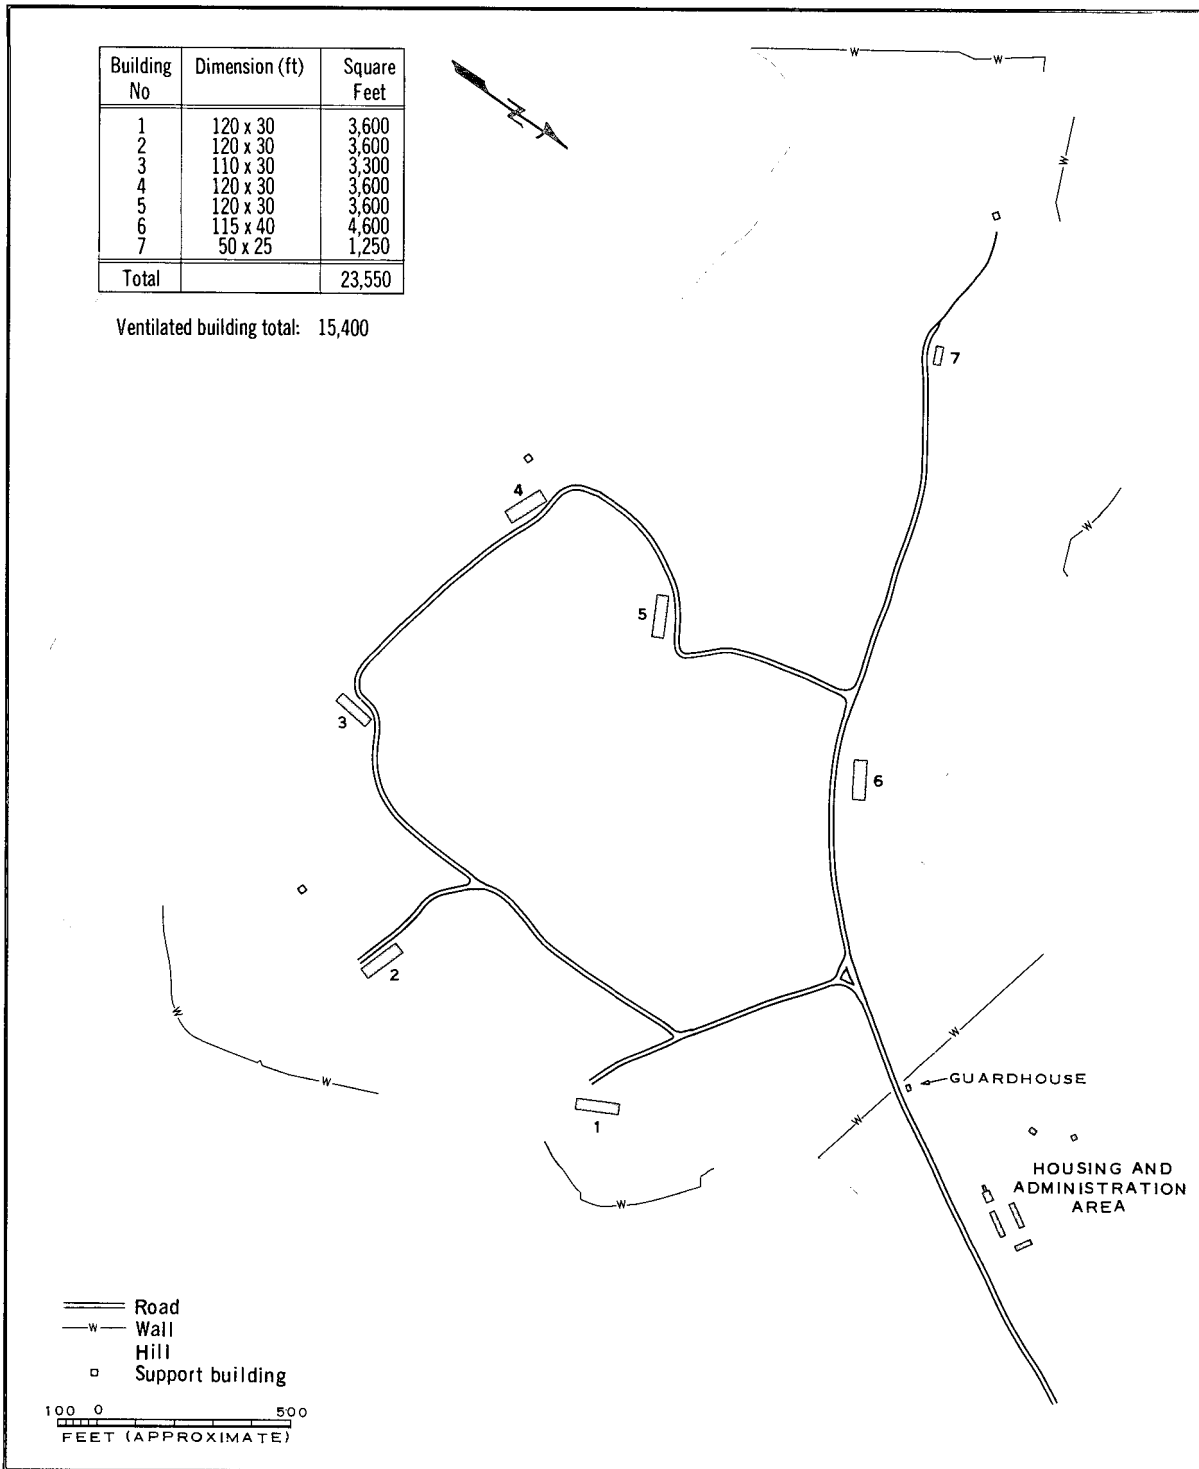
The facilities in the storage area include 6 warehouses, a storage/service building (Building 7, Figure 3) and 3 small support buildings. Each of the 6 warehouses is gable-roofed and has 2 covered entrances located on the side nearest the service road. Stack-type ventilators can be seen along the roof peaks of 4 warehouses (Figure 2). The presence of ventilators on the other warehouses cannot be determined because of the poor image quality of the photography. Although the warehouses are not revetted, their location with respect to each other affords a measure of blast protection. Those warehouses which are not separated by hills are located at a minimum distance of 600 feet from each other.

Existing terrain features and wall sections provide a minimum of perimeter security for the storage area. The valleys between the surrounding hills have been secured by wall sections (Figure 3). Although guard posts could not be located around the perimeter, the 3 small support buildings within the storage area could serve this purpose. A small guardhouse is located near the road entrance to the storage area. The housing and administration area is not secured.

All measurements, with the exception of Building 7 (Figure 3), have been made by the NPIC Technical Intelligence Division and are considered to be accurate within + 5 feet or 5 percent, whichever is greater. Building 7 measurements were made by the IAD project analyst. The line drawing in this report has been rectified.

Figure 3. Munitions storage site near Liu-chou, China
